**MISSOURI**  
DEPARTMENT OF  
NATURAL RESOURCES

**FINDING OF COMPLIANCE**

**Missouri Department of Natural Resources**  
**St. Louis Regional Office**  
**Report of Inspection**  
**Huster Substation**  
**3800 Huster Road, St. Charles, St. Charles County**  
**MO0137642**  
**November 13, 2023**

Pursuant to Section 644.026.1 of the Missouri Clean Water Law, I, Christopher Maher of the Missouri Department of Natural Resources (Department) St. Louis Regional Office (SLRO) conducted a routine water pollution compliance inspection of Huster Substation located at 3800 Huster Road, St. Charles, St. Charles County, Missouri on November 3, 2023.

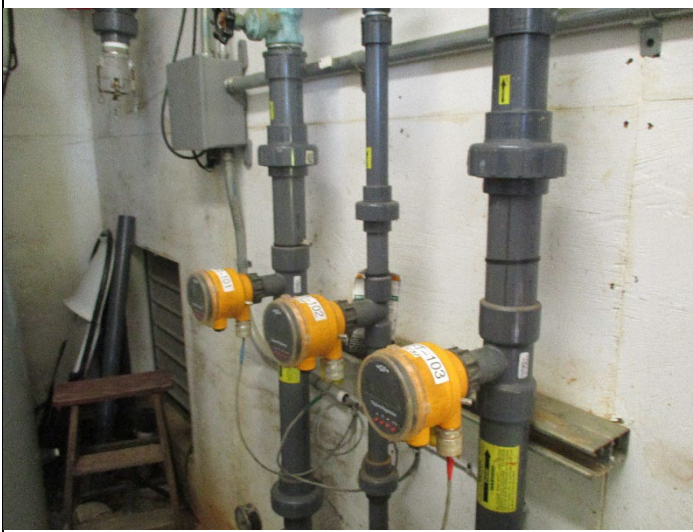
We met with Reggie Gardner and Troy Eppinger with Loureiro Engineering Associates, Inc. Reggie Gardner demonstrated the treatment system within the building. Groundwater is sent into the facility through three wells, with one well in operation at the time (Photo #1) then to a holding tank prior to treatment (Photo #2). Water is sent through bag filters, then to the air stripper for removal of CVOCs (Photos #3 and #4). Following the air stripper, wastewater effluent flowed through an additional set of bag filters and then is pumped to the outfall for discharge.

Photo #: 1  
Taken by: Maher, Christopher  
Entity: Huster Substation  
Permit: MO0137642  
Location: Treatment Building  
Description: Meters for flow from three extraction wells.  
Date Taken: 11/3/2023  
Media: WPC

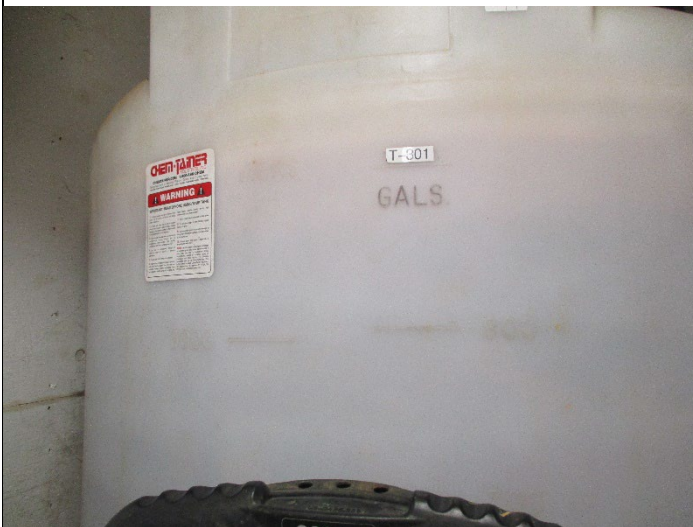
Photo #: 2  
Taken by: Maher, Christopher  
Entity: Huster Substation  
Permit: MO0137642  
Location: Treatment Building  
Description: Storage tank prior to treatment.  
Date Taken: 11/3/2023  
Media: WPC

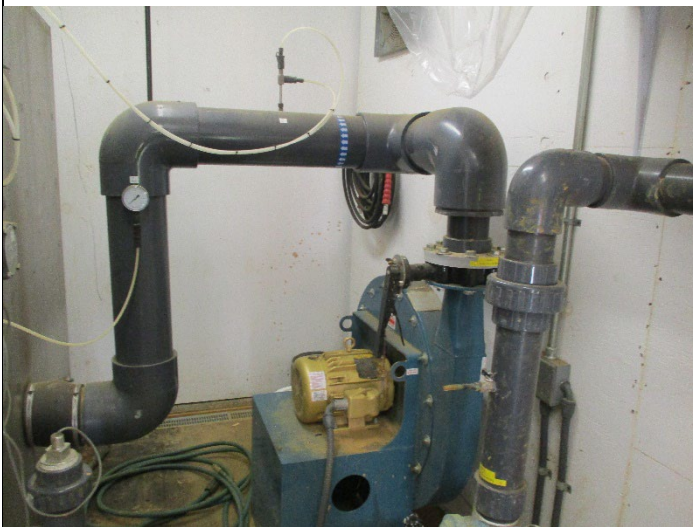
Photo #: 3  
Taken by: Maher, Christopher  
Entity: Huster Substation  
Permit: MO0137642  
Location: Treatment Building  
Description: Air blower motor for air stripper system.  
Date Taken: 11/3/2023  
Media: WPC

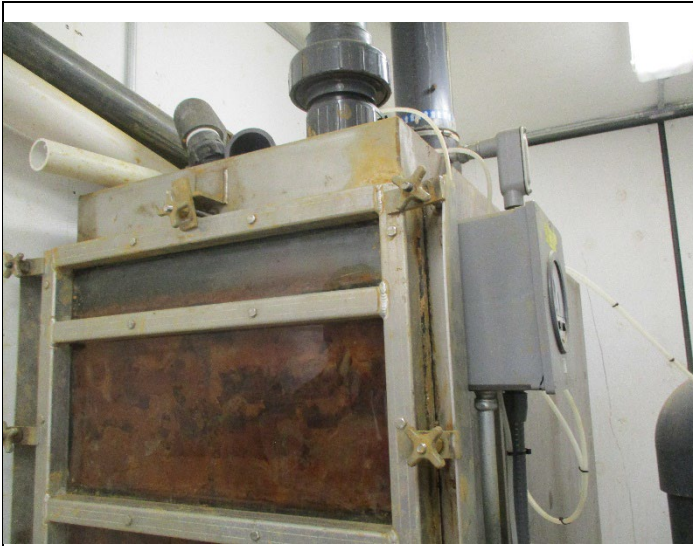
Photo #: 4  
Taken by: Maher, Christopher  
Entity: Huster Substation  
Permit: MO0137642  
Location: Treatment Building  
Description: Air stripper.  
Date Taken: 11/3/2023  
Media: WPC

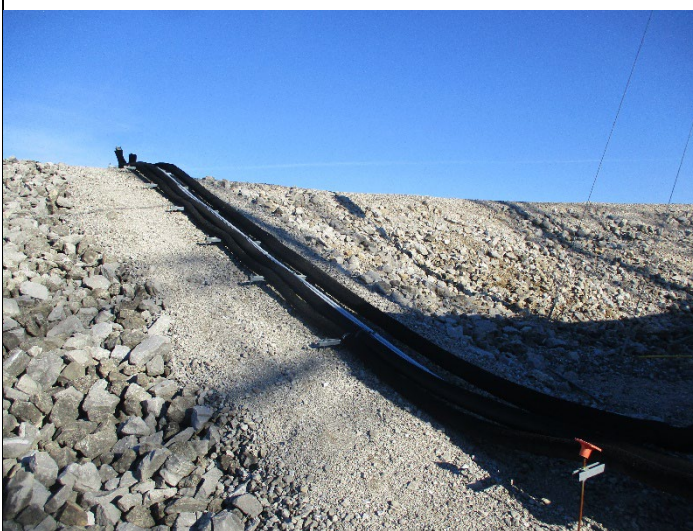
After treatment, wastewater effluent is pumped through the effluent line over the levee berm (Photo #5). The effluent line leading to the outfall descended from the top of the berm (Photo #6). I observed the area below the outfall, which was not actively discharging (Photo #7). The area below the outfall was wet with an orange-red appearance. Due to vegetation and standing water conditions in the area, I was unable to get a direct view of water surrounding the outfall pipe.

Photo #: 5  
Taken by: Maher, Christopher  
Entity: Huster Substation  
Permit: MO0137642  
Location: Near Treatment Building at Levee  
Description: Effluent line on right side and influent line over levee berm; facing north.  
Date Taken: 11/3/2023  
Media: WPC

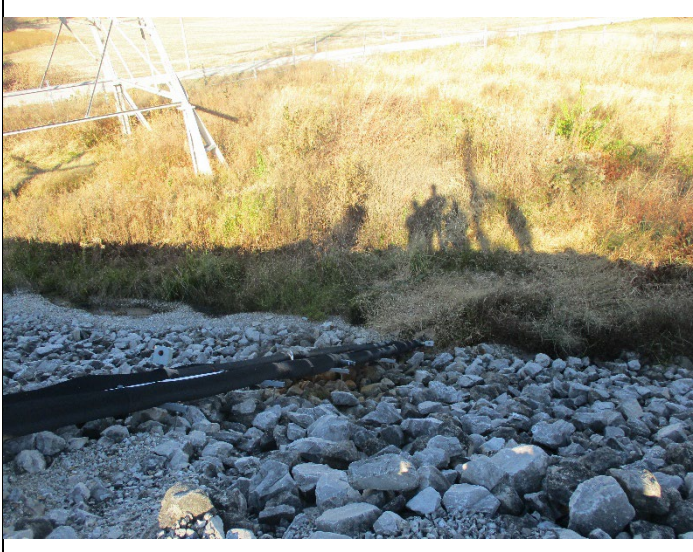
Photo #: 6  
Taken by: Maher, Christopher  
Entity: Huster Substation  
Permit: MO0137642  
Location: Northwestern Portion of Facility  
Description: View of discharge line from top of levee berm; facing northwest.  
Date Taken: 11/3/2023  
Media: WPC

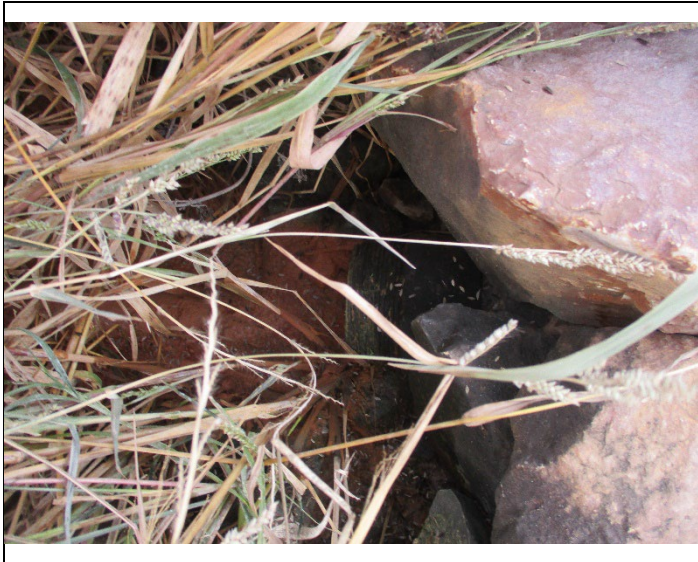
<p>Photo #: 7 Taken by: Maher, Christopher Entity: Huster Substation Permit: MO0137642 Location: Outfall #001 Description: Outfall not actively discharging; facing northeast. Date Taken: 11/3/2023 Media: WPC</p>

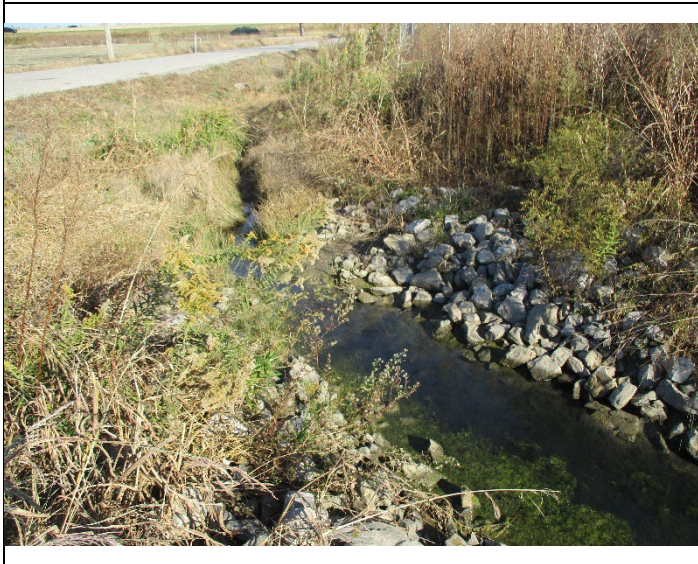
I observed standing water below a stormwater outfall leading from the site (Photo #8). The drainage characteristics of the site flowed to the north and met with the drainage from Outfall #001. The water flows entered a road culvert under Huster Road to the west (Photos #9 and #10).

<p>Photo #: 8 Taken by: Maher, Christopher Entity: Huster Substation Permit: MO0137642 Location: Stormwater Outfall Description: Water flow from stormwater pipe upstream of meeting flow from Outfall #001; facing northwest. Date Taken: 11/3/2023 Media: WPC</p>

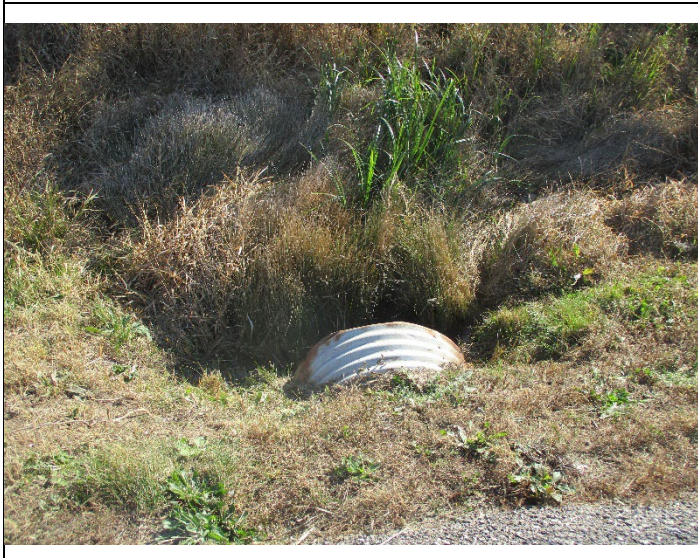
<p>Photo #: 9 Taken by: Maher, Christopher Entity: Huster Substation Permit: MO0137642 Location: Huster Road Description: Culvert on upstream (eastern) side of Huster Road; facing east. Date Taken: 11/3/2023 Media: WPC</p>

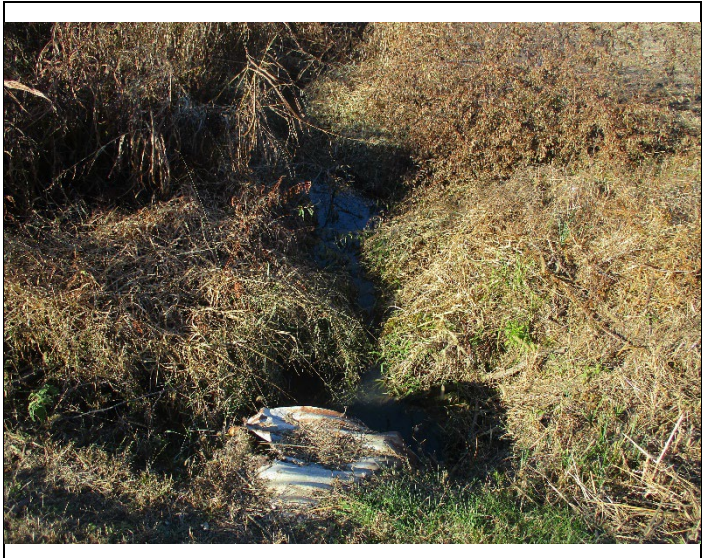
Photo #: 10  
Taken by: Maher, Christopher  
Entity: Huster Substation  
Permit: MO0137642  
Location: Huster Road  
Description: Water flow on the downstream (western) side of road culvert at Huster road; facing west.  
Date Taken: 11/3/2023  
Media: WPC
