**Evaluation of Soil Gas Data Collected at the
Center for Women in Transition
304 N. 5th St., 504, 506, and 508 E. Church St.
Champaign, Illinois**

**Ameren Services
One Ameren Plaza
1901 Chouteau Avenue
MC 602
St. Louis, MO 63103**

**RAM Group of Gannett Fleming, Inc.
5433 Westheimer Road, Suite 725
Houston, TX 77056
Ph: (713) 784-5151 Fax: (713) 784-6105
e-mail: asalhotra@ramgp.com**

January 2010

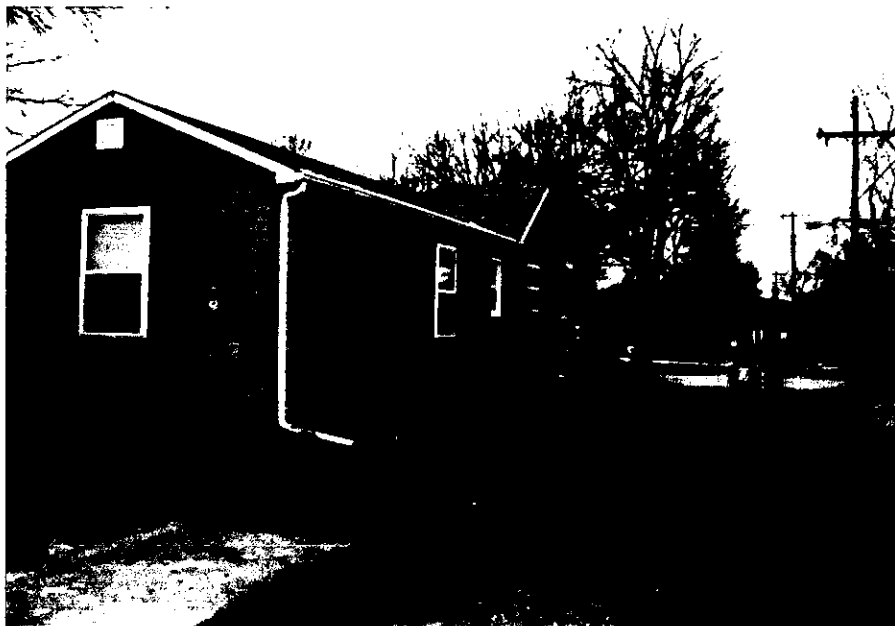
PHOTO 2: View of 304 North 5th Street northeast corner looking southwest from alley. 304-N sampling location to right of building about mid-way along north side. North 5th Street is visible in background.

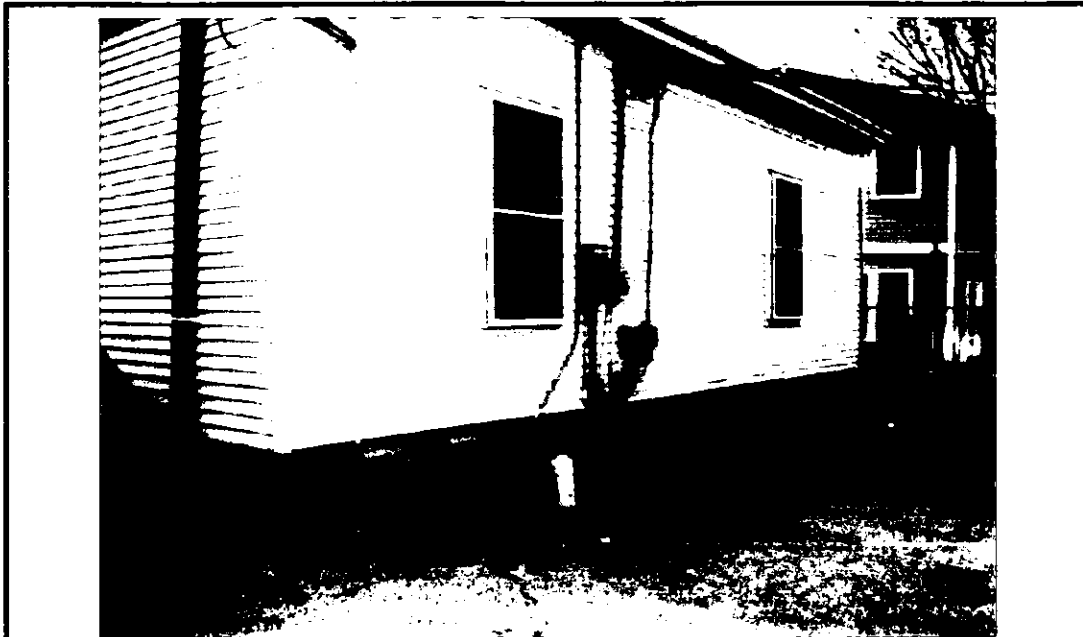
PHOTO 7: View to southwest along north side of 506 Church Street building. 506-N sampling location was in grass between windows.

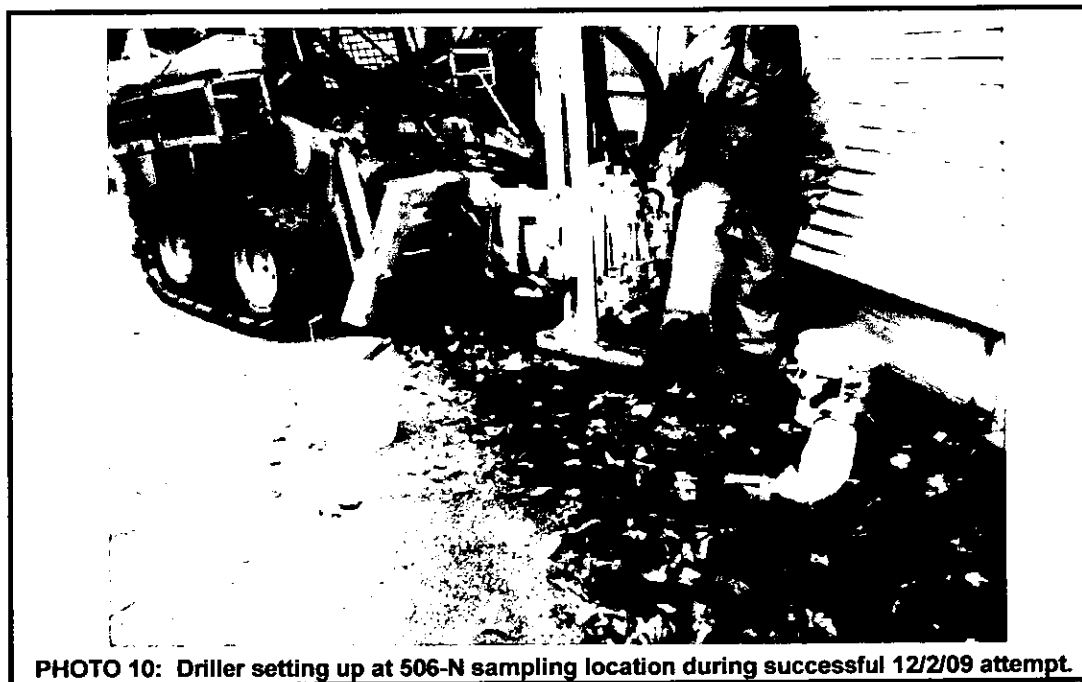
PHOTO 10: Driller setting up at 506-N sampling location during successful 12/2/09 attempt.

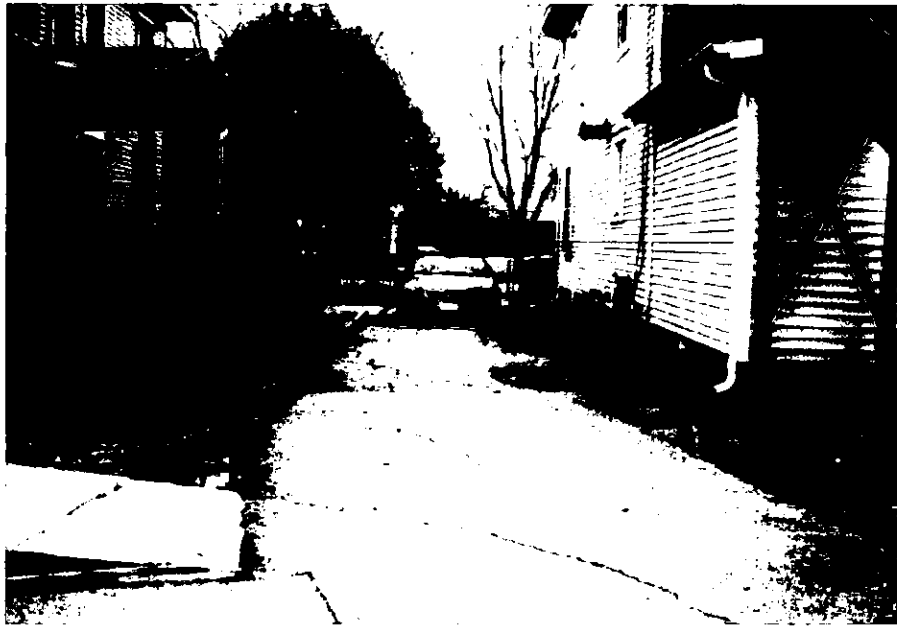
PHOTO 11: View to south along 506 Church Street driveway. 506 Church Street on right; 508 Church Street on left. 506-E sampling location in grass between hose and near corner of building. 506-E-AMB ambient air sample from left side of driveway next to shrubs.

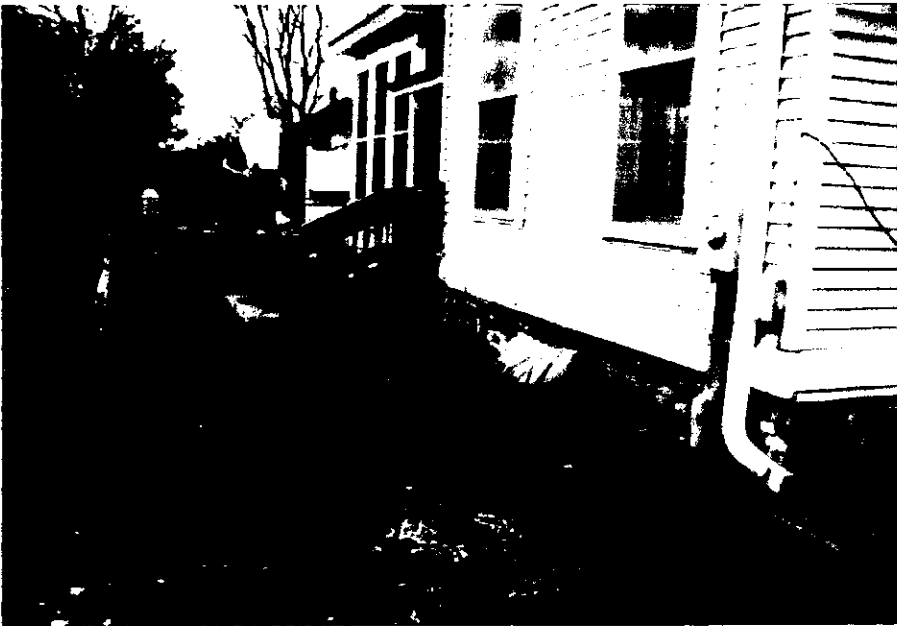
PHOTO 14: View south along east side of 508 Church Street. 508-E sample collected in grassy area just beyond vegetable garden left of second window from near corner.

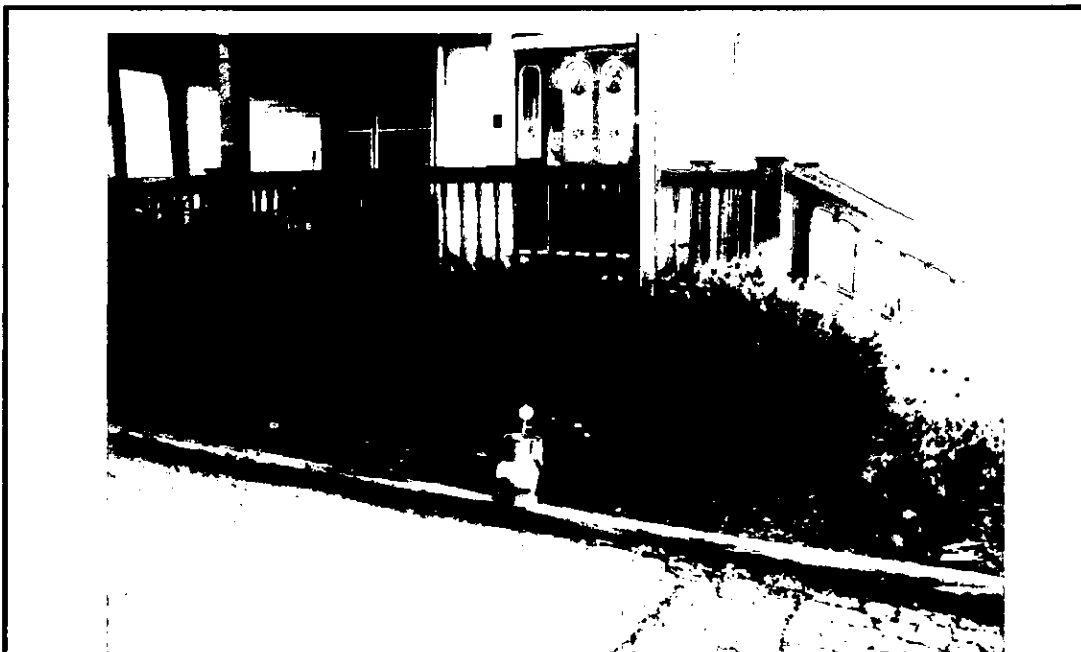
PHOTO 16: View of 506-E-AMB ambient air sampling location east of 506 Church Street and west of 508 Church Street. 508 Church Street building in background.
